# Microwave Repair

## (A) Magnetron

CODE NUMBER
74752-0058-00
MODEL NAME
JE1540, JE1530, JES1533
GE

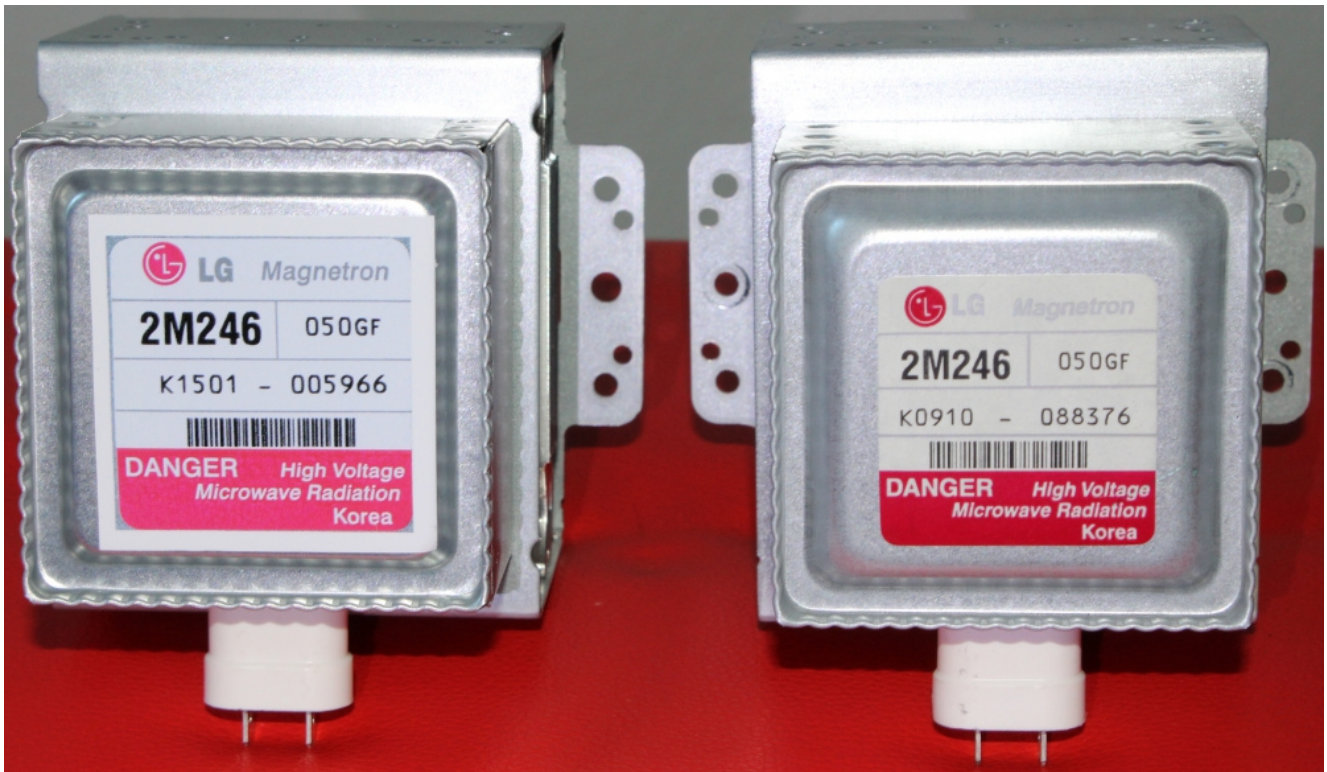
Microwave stopped working all of a sudden.

Due to the magnetron which emits powerful UHF (Ultra High Frequency, usually 2.45GHz is applied for consumer microwave) electro-magnetic wave to jumble water particles in material targeted to be got heated is a sort of old-fashioned vacuum tube driven by directly heated filament, the lifetime is not eternal (definitely much shorter than semiconductor although high voltage semiconductor is hard to manufacture stably).

New & Old (Broken) Magnetron

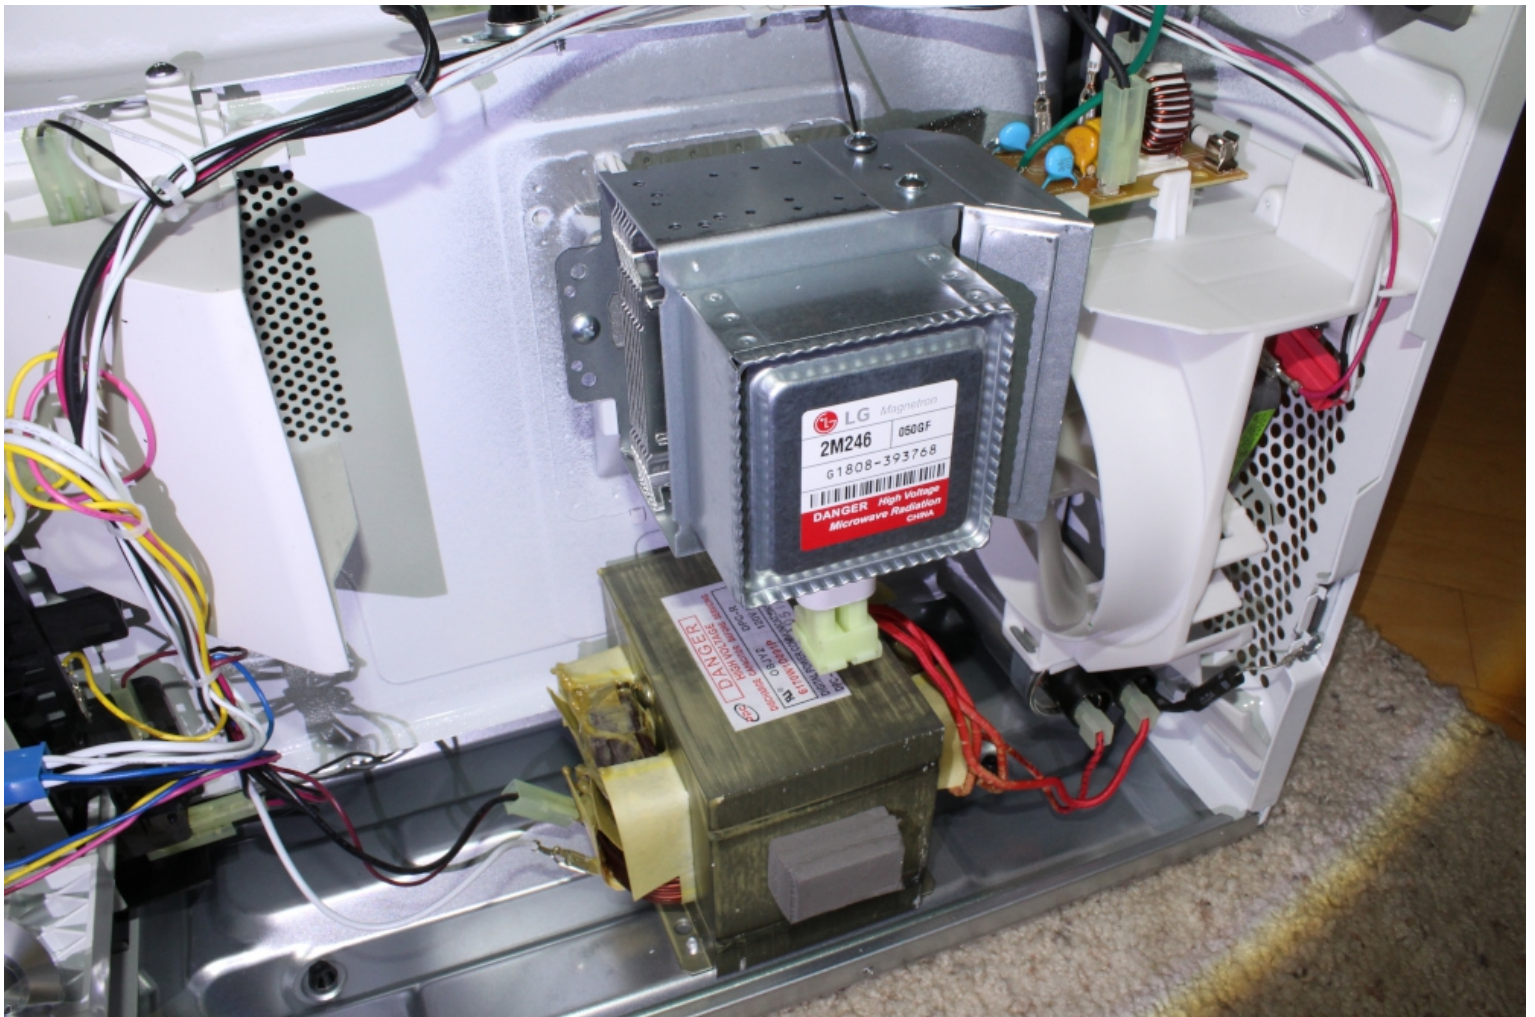
New Magnetron Assembled

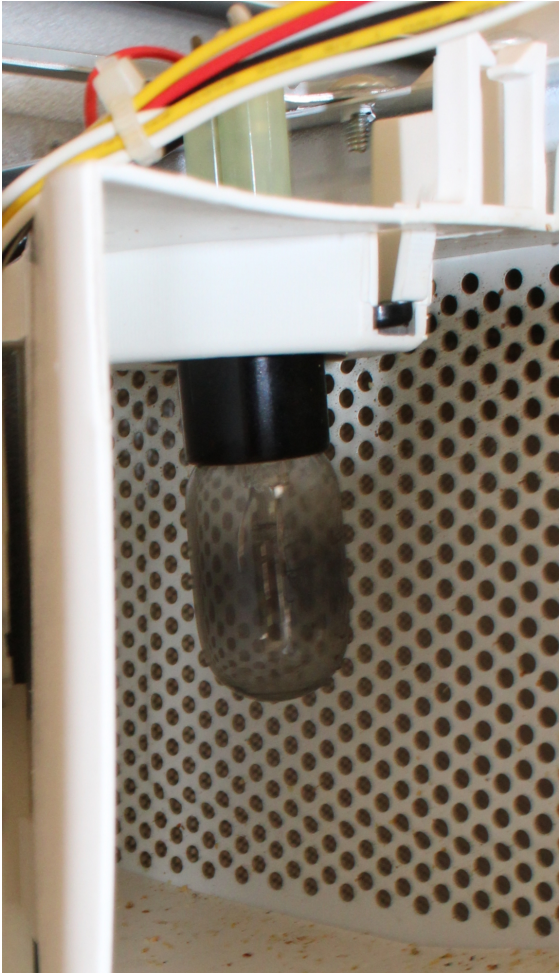
Burnt bulb (20W)

Filament of the light bulb was burnt and became not lit.

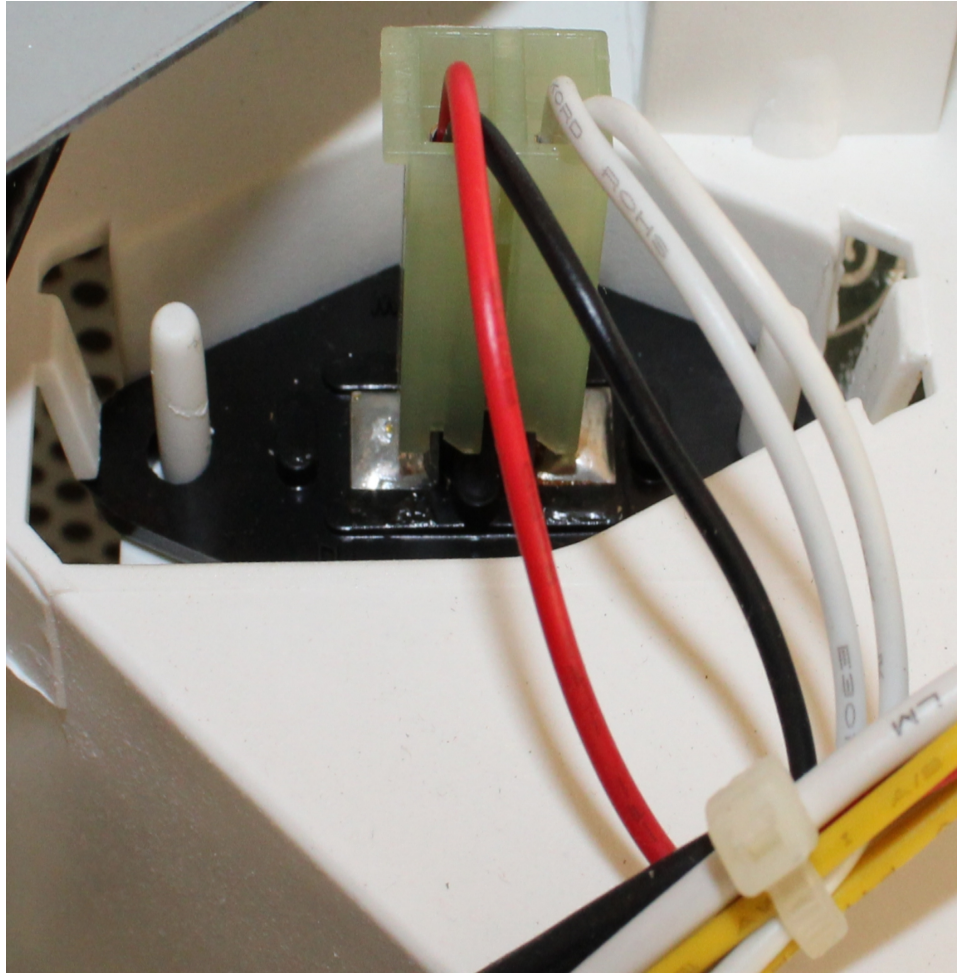
Bulb cartridge terminal

The cartridge of the light bulb is expensive (\$25).

Fortunately because I had a 40W small incandescent light bulb as a stock, I soldered two wires between the bulb stem and the cartridge terminal, and put it beside the non-working bulb without removal.

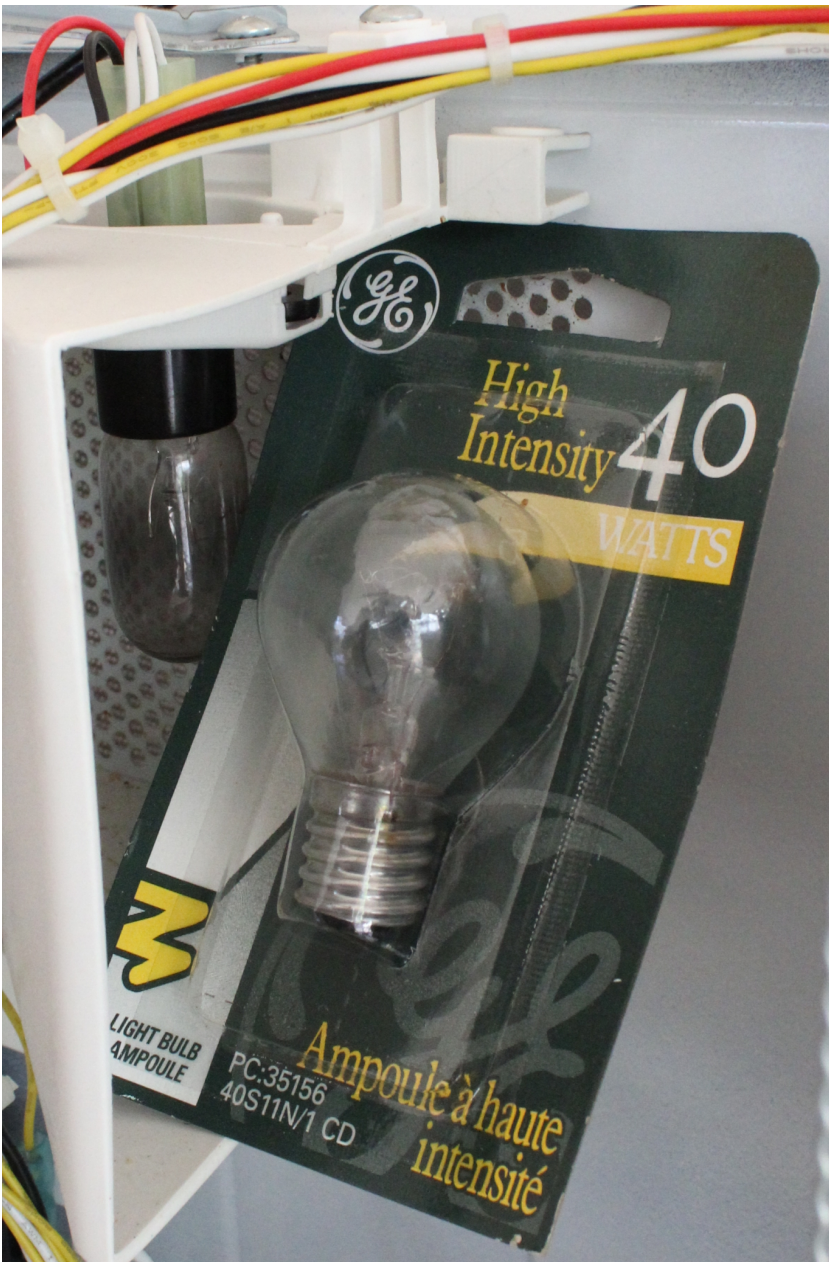
Old & New bulb

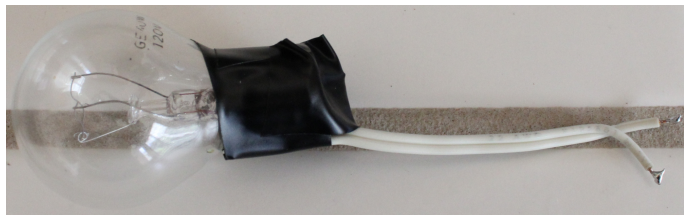
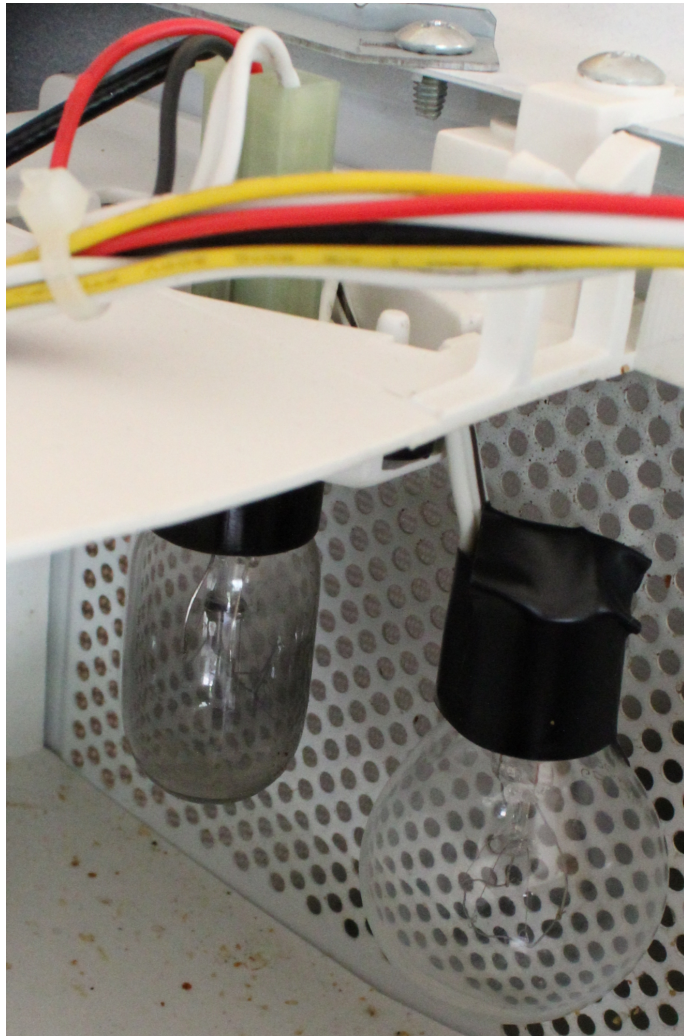
Old & New bulb wired

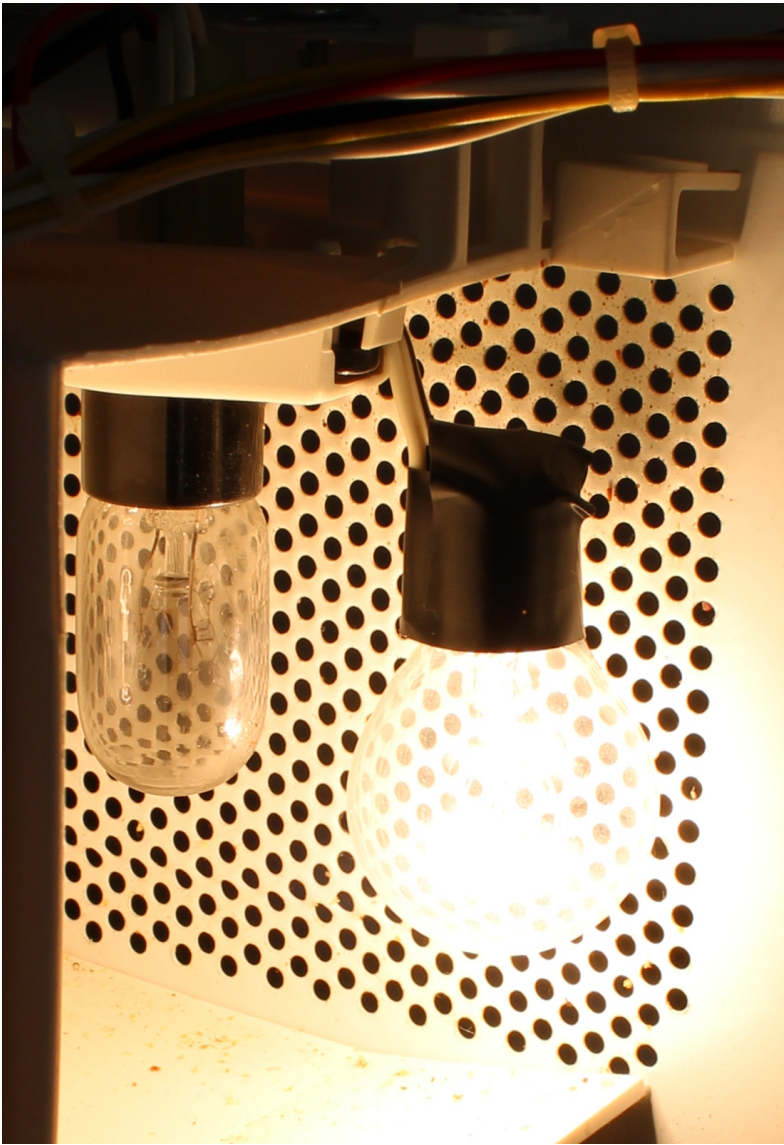
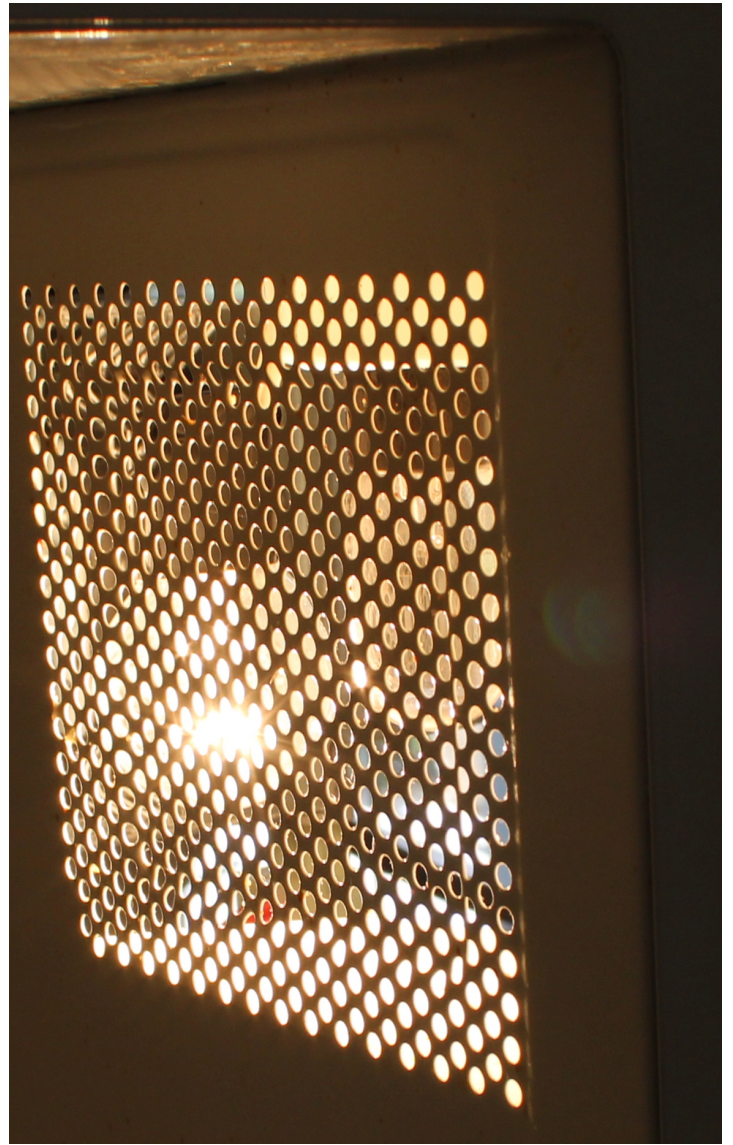
Light bulb turned on
