Repair Pendulum Clock

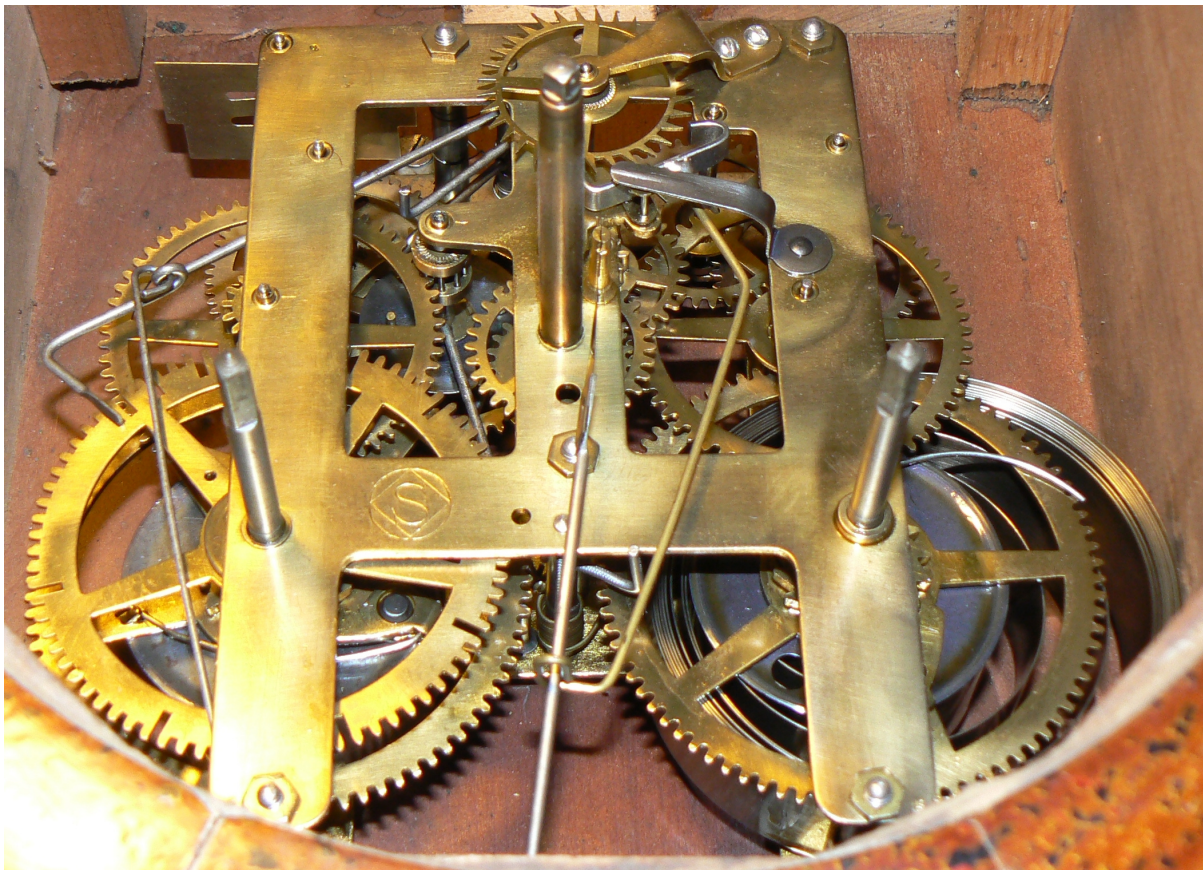
Clock mechanism (Pawl rod for main spiral torsion spring (right) broken, Pawl for chime spring (left) intact)

Due to a broken pawl rod for main torsion spring, the ratchet cannot stop the main spring loosening.

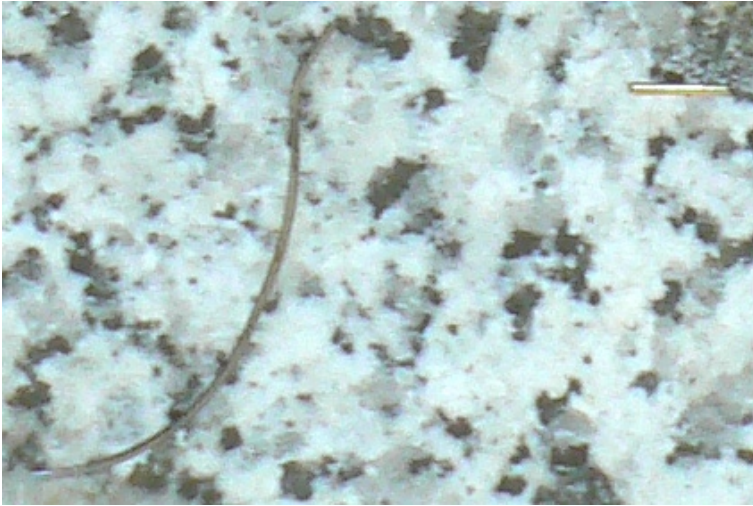
Broken pawl rod for main spring

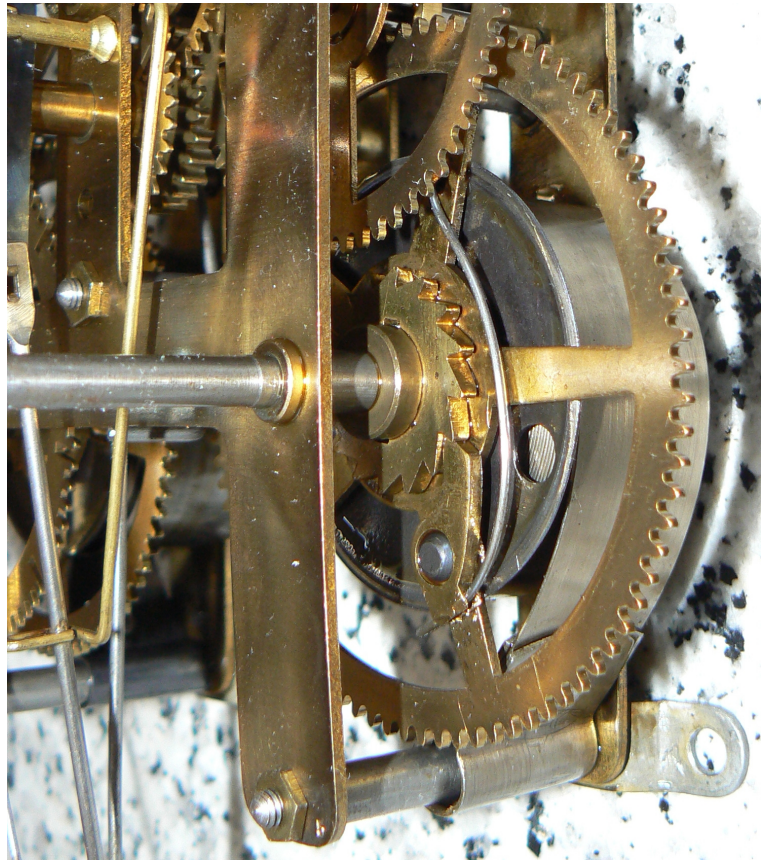
Assembled back (Pawl rod not touched to cam)

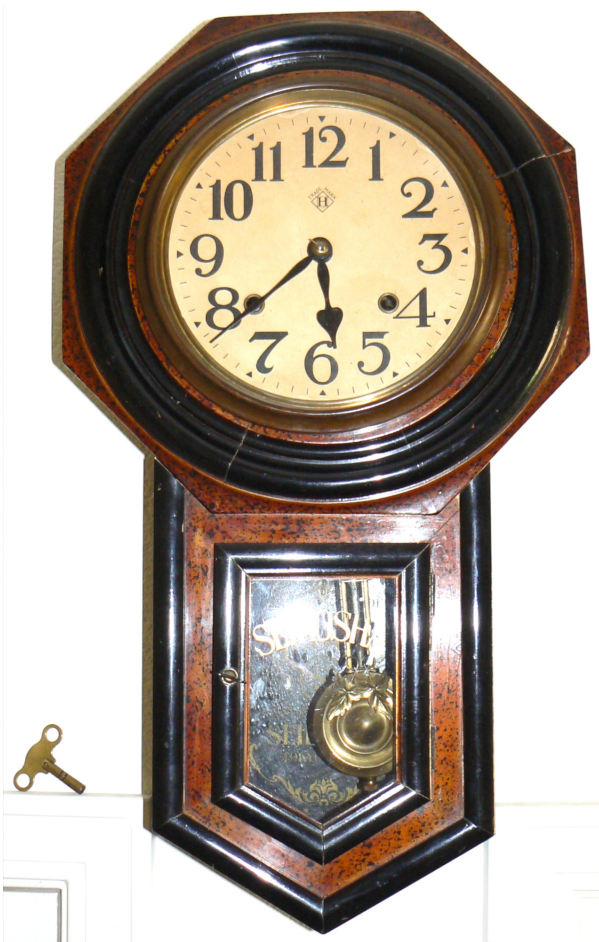
Pendulum moving left & right

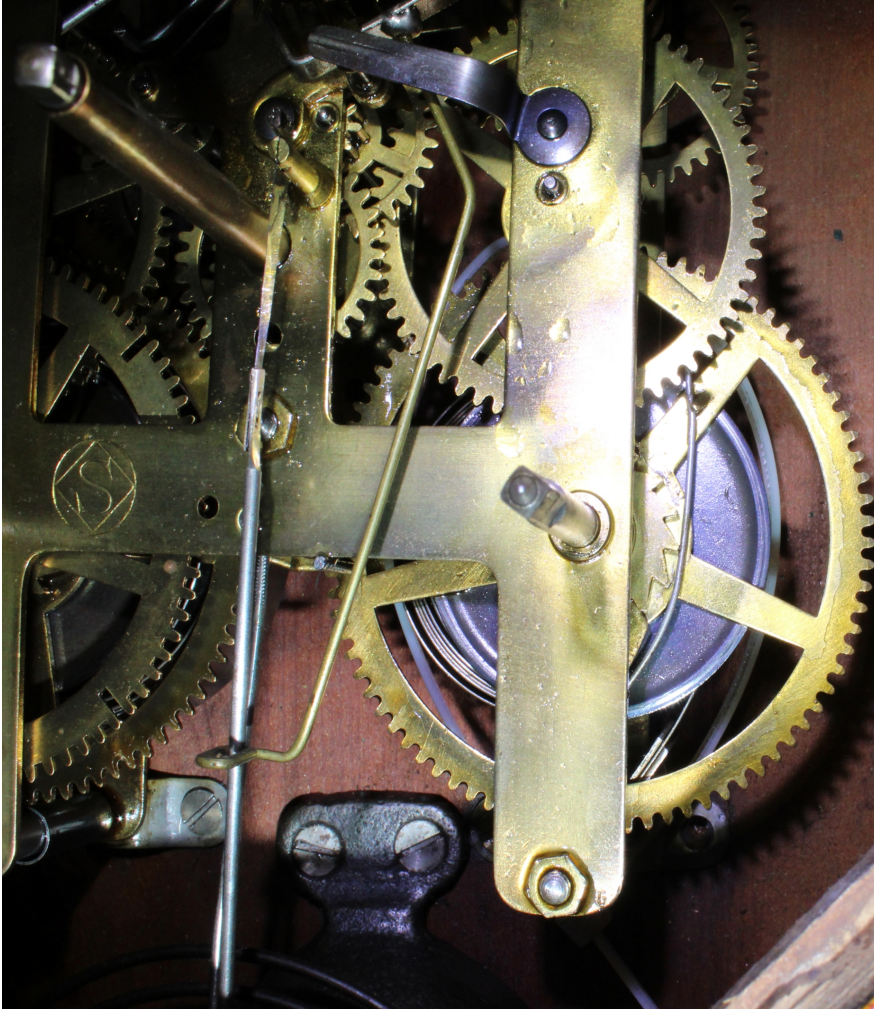
The pendulum movement became weak and eventually stops even though the main spring is sufficiently wound.

The reason was that the pawl rod, I reinstalled as shown above, loosened and touched the spring cam and made big friction against the main spring.

Pawl rod touched to cam and pushed it ↑

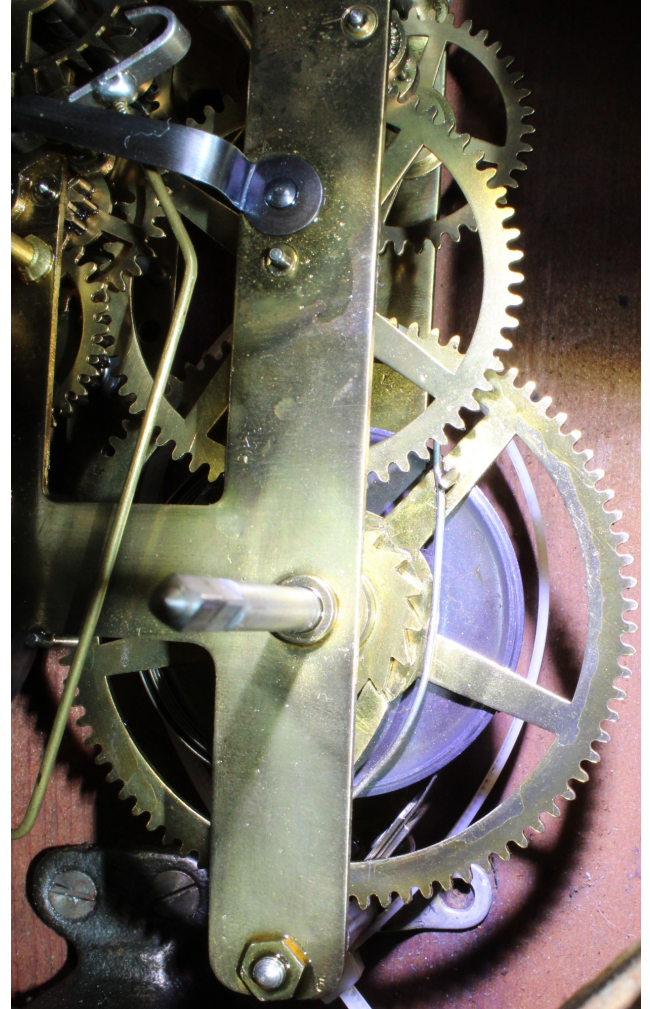
Pawl rod separated ↑ (Resurrected)
